BRITISH PARACHUTE ASSOCIATION
Kimberley House
47 Vaughan Way
Leicester
LE1 4SG

SAFETY INFORMATION

9th March 1987

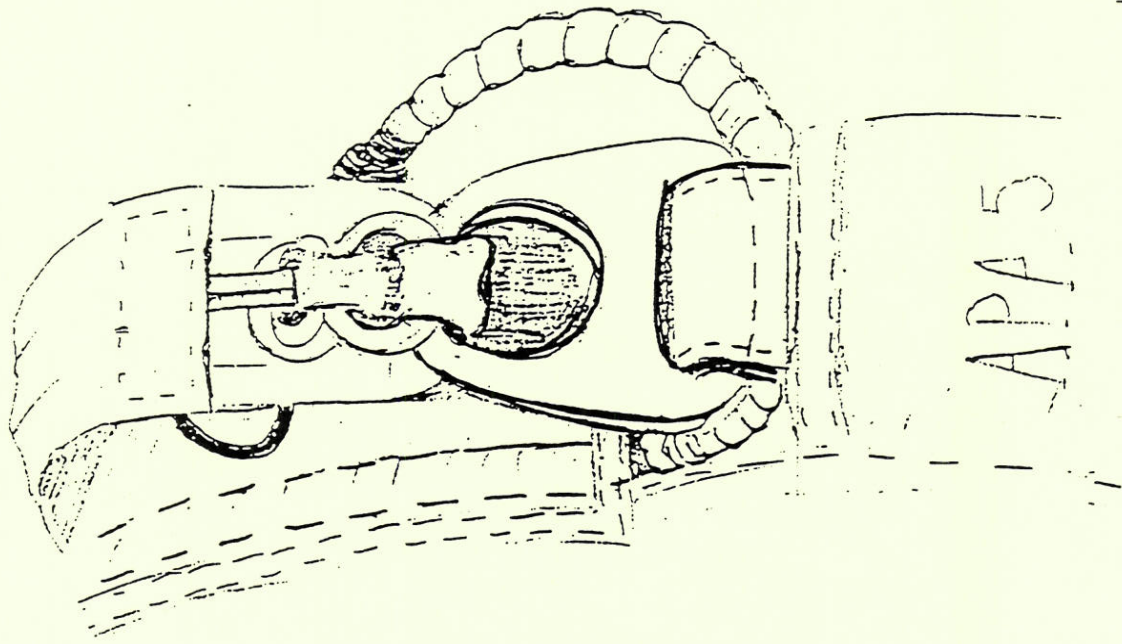
A.

An incident occurred at Netheravon, where after a malfunction, the parachutist was unable to cutaway from a Chaser, due to the incorrectly routing of the cutaway housing. A number of other Chasers at JSPC-N were checked and the cable housings were found to be routed in the same manner (see drawing A - over page). The routing of the cutaway housing was changed to that of drawing B (over) to facilitate an easier pull.

All parachutists should check the routing of their cutaway housings and should check the pull, especially with some tension on the risers.
