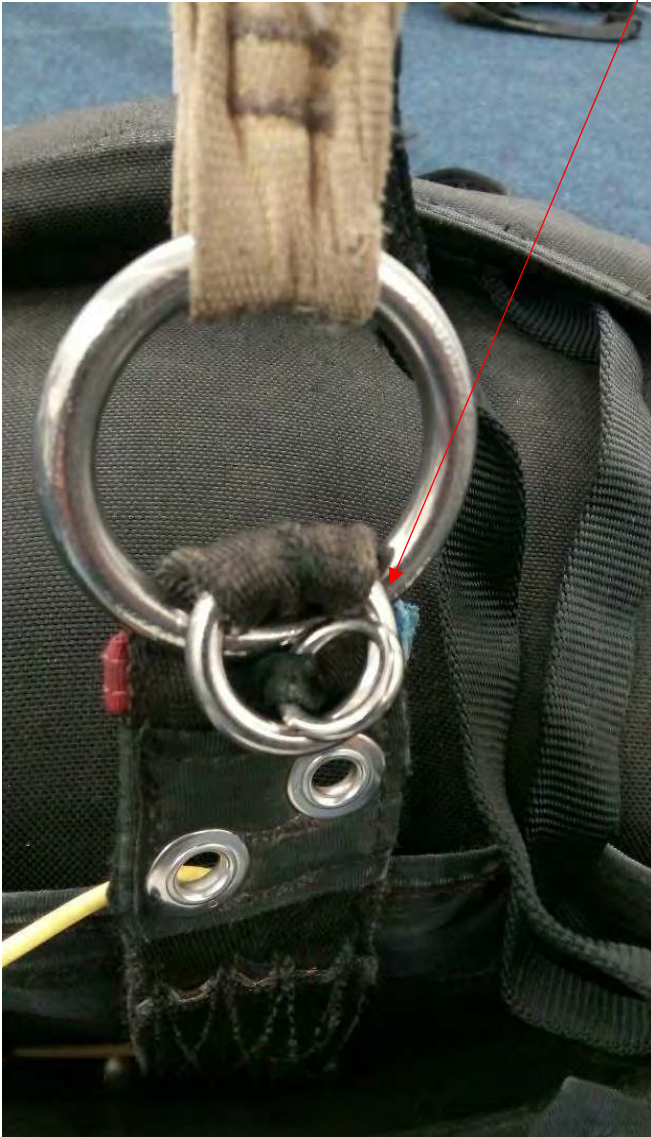
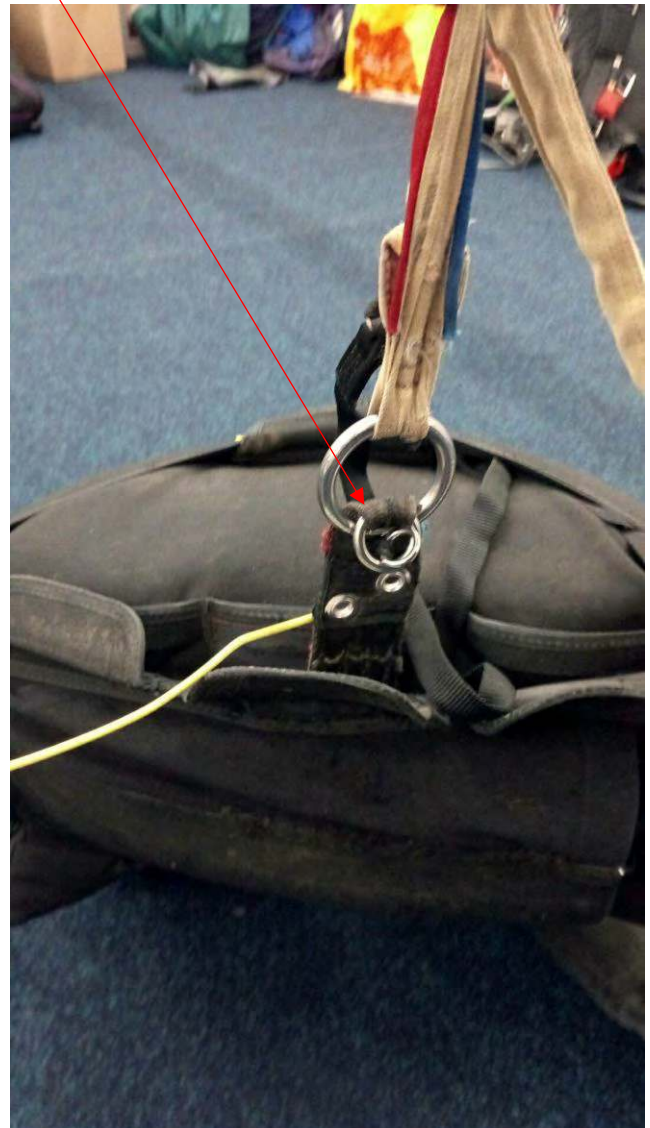
## APPENDIX A

During the landing the drogue was trailing behind, and both Instructor and Student landed safely. On inspection of the equipment shortly after landing, the CI noticed the drogue was still attached to the drogue riser, however the double ended loop on the Next system was not there.

The cause of the deployment problem was the small ring on the drogue riser, which was twisted 180 degrees, causing a lock between the middle ring and the drogue ring and preventing the middle ring from releasing.

It is believed that the problem was caused by a packing error.

Twisted small ring causing lock between middle riser ring and drogue ring.

(Error recreated on a different set of equipment)

The CI has reminded and reiterated to all his Instructors and Packers the importance of checking the drogue riser and the position of the rings as part of their equipment check before moving to flight line. A photograph re-creating the problem on another set of equipment was shown to those present. As this incident was not a common occurrence, it was decided to attach a copy of this photograph with the Minutes for information (Appendix A).
